**Flood Control Project Maintenance  
Levee Inspections**

## Maintenance Issue Types Only, Levee Inspection Report By Mile - Spring 2016

### Reclamation District No. 1500 Sutter Basin

Waterway	Bank	Unit Miles	Inspection Start/End	Inspector
Unit No. 01 Sacramento River	Left	33.15	03/09/2016 03/10/2016	Jai Lor

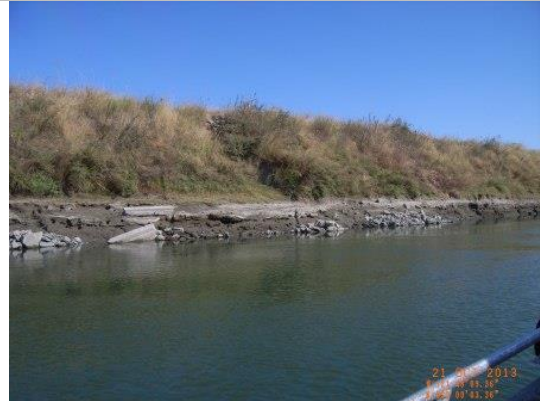
Photo 1 of 1 : SP\_2016\_RD1500\_189\_22\_20160304\_00022.jpg

LM Start	30.60	Rating **	A/W	Issue No.	22
LM End	30.75	Issue Type +	Ma	Location *	WS
Category	Supplemental			GPS Latitude/Longitude	
				Start	End
Item	2015 USACE Erosion Survey, DRAFT			38.999745 °	39.001413 °
				-121.800898 °	-121.802889 °
DWR ID	DWR_RD1500_01_s_2016_22				
Comment Code					
Inspector Comment					
2000 - Eroding, vertical berm slope over a vertical cohesive toe; slow erosion but getting close to the toe. 2002 - Erosion is getting close to the levee, still eroding with some new small slumps. 2004 - Some minor new erosion. 2006 - Some new erosion, cleaned off older scars and slump faces. 2008 - New, small, partial rotational failure. 2011 - Some new minor erosion. 2015: No observed changes. [2015 Site ID: SAC_116-0_L]
